## **The Taming of Mt Tyre**

Laurie Gardiner, MWH New Zealand Ltd

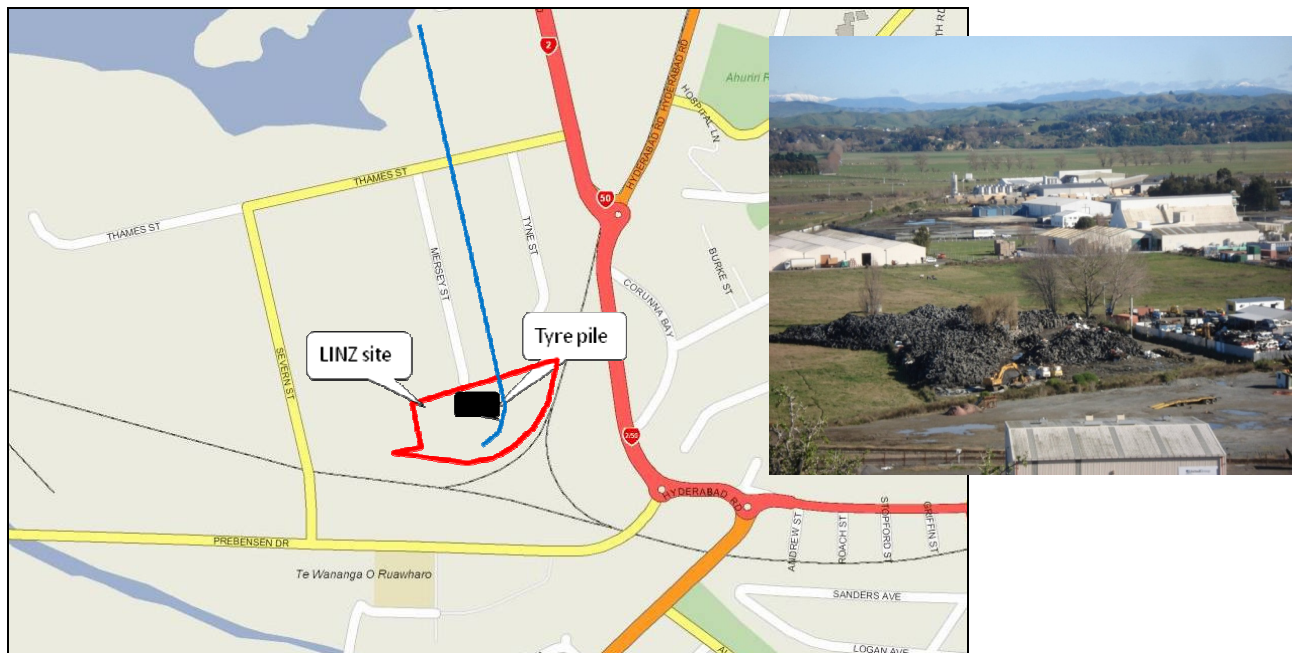
**Figure 1: Site location (inset Photo1: view of Mt Tyre from Hospital Hill in July 2008)**

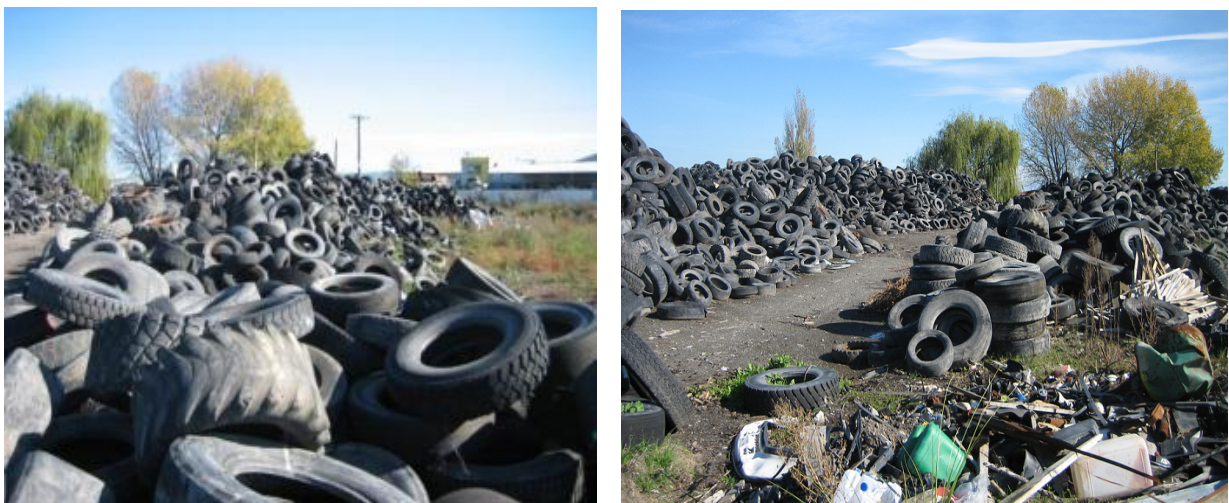
The pile comprised an unsorted mix of used car, truck and agricultural tyres (Photos 2 and 3) spread over an area of approximately 0.5ha towards the centre of the land parcel (see enlarged site plan in Figure 2). The overall dimensions of the pile were 73m (west boundary) and 107m (south boundary), with the height varying from 5m on the west side to <1m on the east due to irregular stacking. Running across the pile was a 6m wide track accessed from the south end of Mersey Street. The dump was estimated to have a volume of approximately 15,000m<sup>3</sup>, equivalent to about 2000 tonnes of waste tyres.

**Photos 2 and 3 (right): Views of Mt Tyre dump from central access track (2009)**

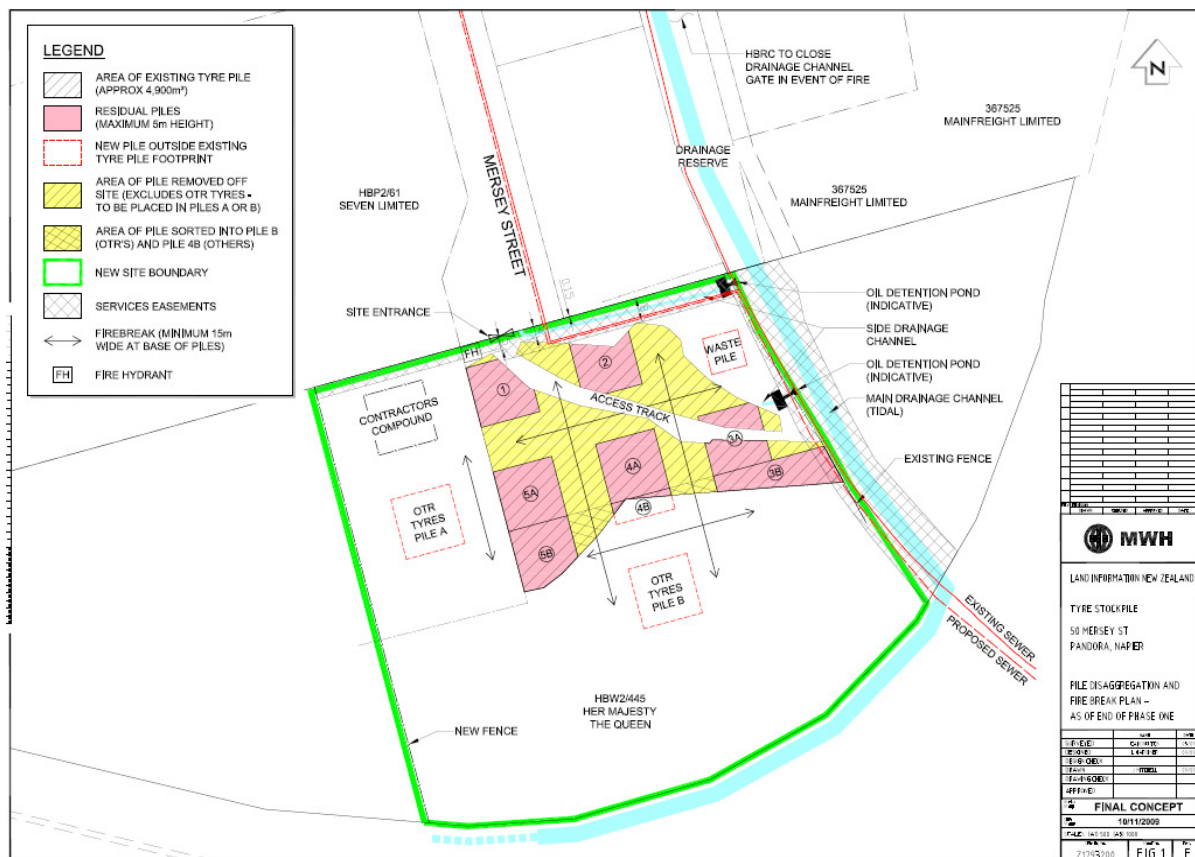
**Figure 2: In-Situ Pile disaggregation and firebreak plan (end of Phase 1)**

An *in situ* disaggregation method was proposed by MWH to achieve this goal by initially removing tyres so that the cleared areas created a firebreak grid within the original pile. The method is illustrated in Figure 2. The hatched envelope represents the surface area of the original tyre pile. The contractor initially removes tyres from the yellow hatched area of the dump (Phase 1), so creating the 15m wide firebreak grid within the original tyre pile. The resultant smaller tyre piles (red hatched squares), now with easier fire-fighting access and a much reduced fire risk, are subsequently removed in Phase 2.

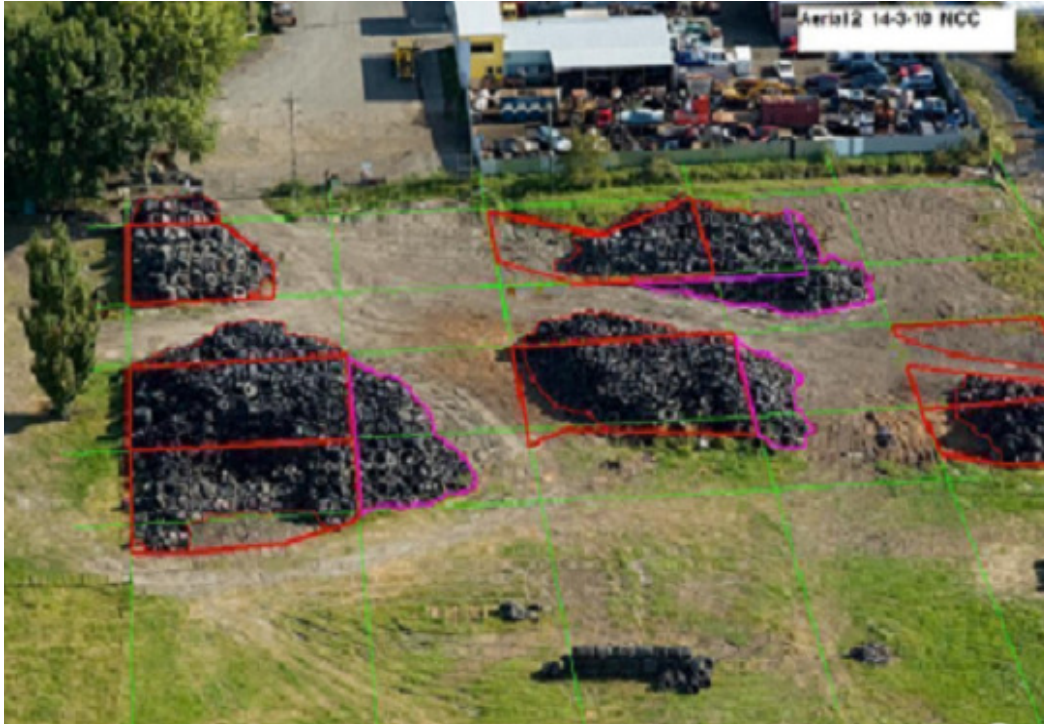
**Photo 4: *In-situ* pile disaggregation creating the fire break grid and smaller piles**

Aerial photos (provided by NCC) were used to indicate overall progress in tyre clearance in combination with observations and measurements on the ground. Photo 4 shows the disaggregated dump and firebreak grid in March 2010 during Phase 1 with about 40% tyres cleared. The red overlay shows the pile configuration required to meet the planned Phase 1 end point (see Figure 2). Piles needing further clearance are shown by the purple lines.

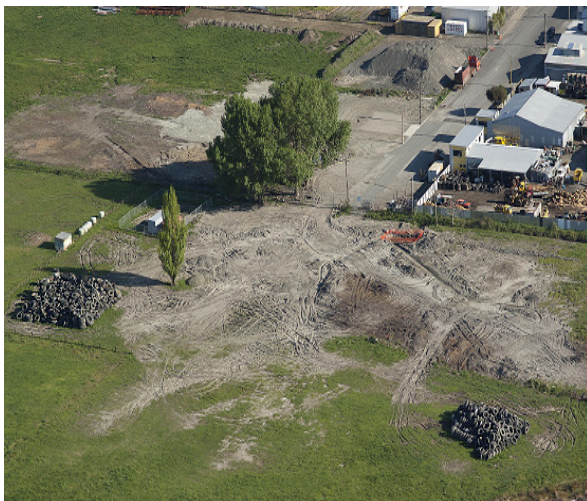
**Photo 5: (left) End of Phase 2 with two OTR tyre piles remaining  
Photo 6: (right) End of Phase 3 with site fully cleared (January 2011)**

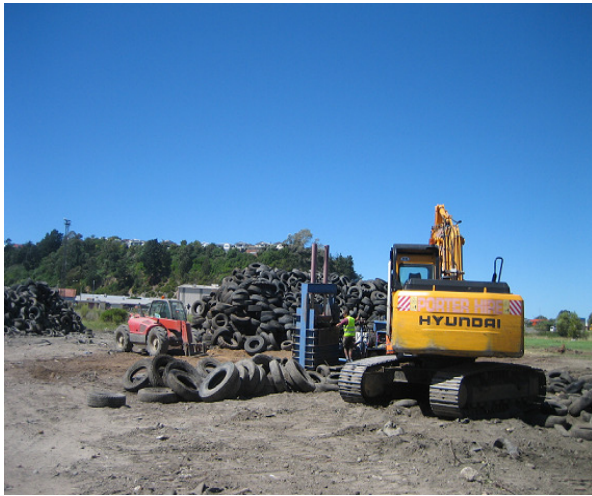
**Photo 7: Baling selected tyres on site**

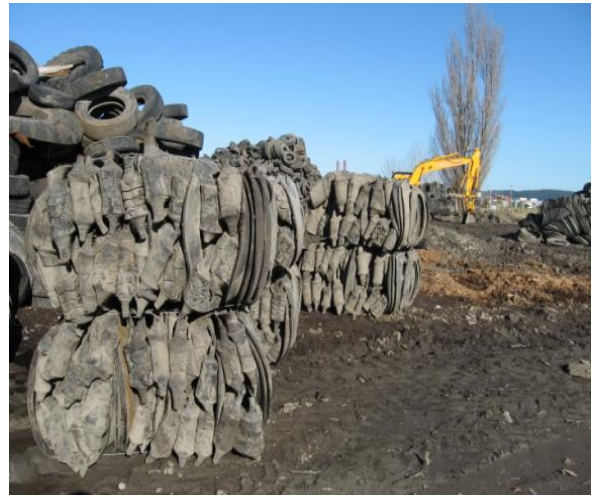
**Photo 8: Tyre bales awaiting despatch**

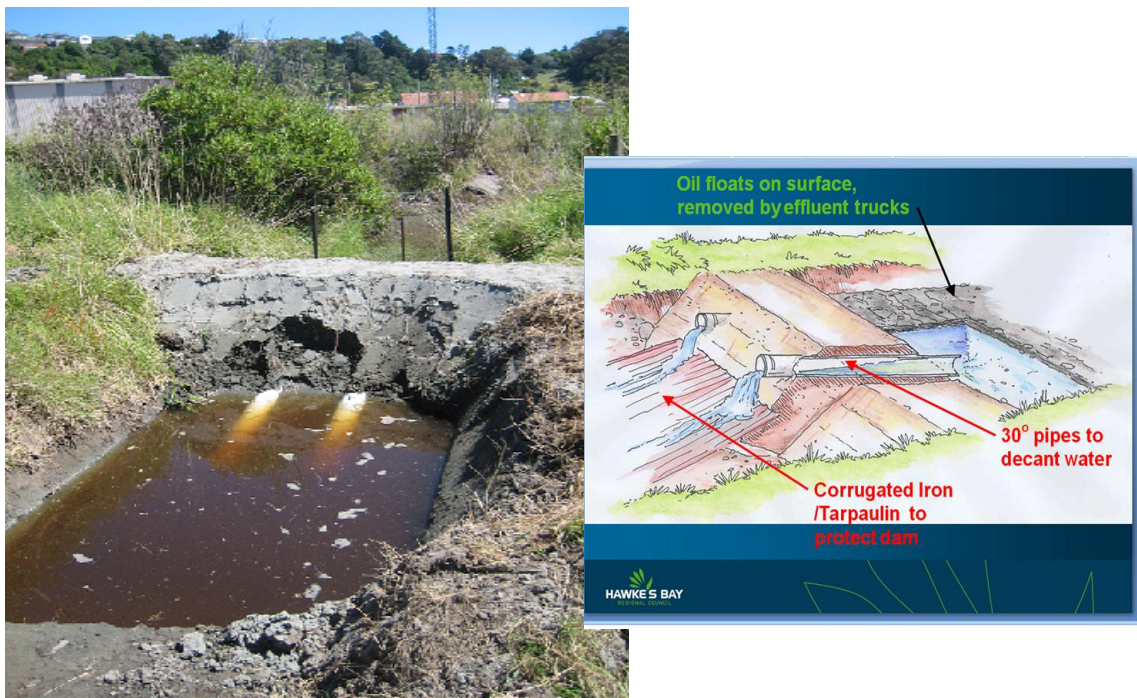
Environmental control measures at the site included the installation of two simple oil detention ponds to intercept and prevent the majority of oily effluent entering the drainage reserve in the event of a fire at the tyre pile during the works (Photo 9).

**Photo 9: Installed oil detention pond and insert schematic diagram (source: HBRC)**

Each device comprised an excavated pit on the side closest to the tyre pile that is connected to the drainage channel by an inclined culvert pipe. In a fire, the oil fraction collects on the pond surface and is prevented from entering the drainage channel through the submerged

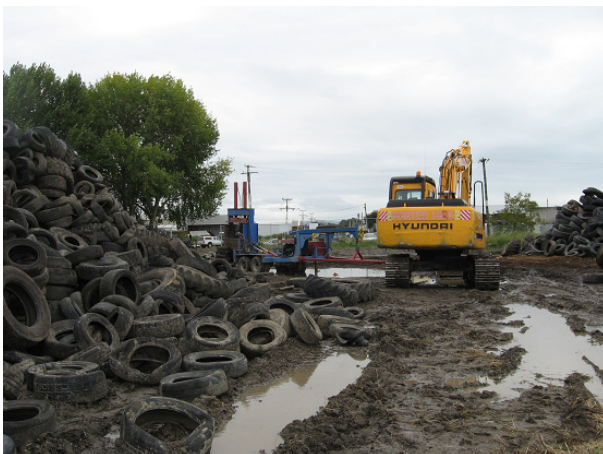
The site works were spread over one year and the weather was at times challenging and occasionally curtailed operations. As the area is reclaimed land, prolonged heavy rains combined with plant movements turned parts of the site's surface into a slurry with extensive water ponding (Photo 10). Additional site drainage measures agreed in consultation with HBRC (i.e. a surface trench leading to a settlement pond and Supersilt fencing at the point of discharge to the site's drainage channel) were later introduced to remedy the situation.

**Photo 10: Ponding due to poor drainage      Photo 11: Dusty site conditions in summer**

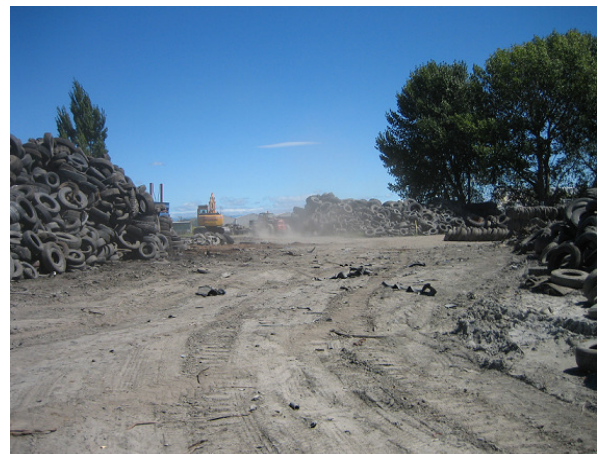
During persistent dry and windy conditions in summer, vehicles traversing the powdery surface near the site entrance and the truck haul route along the fire breaks (Photo 11) raised dust clouds which could potentially cause nuisance at the adjoining premises in Mersey Street. To meet the air permit condition limiting airborne discharges beyond the site boundary, contingency measures were included in the Site Health, Safety and Environmental Management Plan to prevent this occurring.

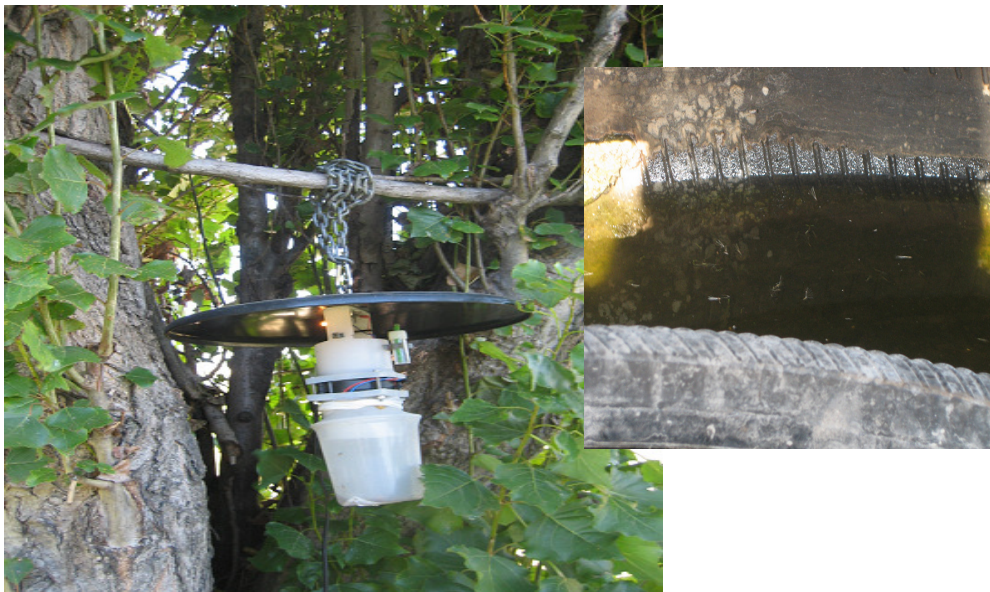
**Photo 12: Light trap for mosquito surveillance (inset: mosquito larvae in tyre on site)**

Monitoring by examination of trapped specimens at the entomology laboratory confirmed the absence of exotic species at the site. The risk of mosquitoes from the Mt Tyre pile was principally a public nuisance concern with the critical period restricted to the warmer summer months. This was exacerbated during tyre clearance by the exceptionally warm and humid weather Napier experienced in 2010.

This aspect was managed by a mosquito plan agreed with the City's Public Health Unit and implemented by a specialist contractor (NZBiosecure). The plan included periodic dosing of the tyre pile to prevent larvae developing to the adult stage. Surveillance comprised larval checks in tyres and trapping adult mosquitoes light traps (Photo 12) to check the effectiveness of dosing measures on site.

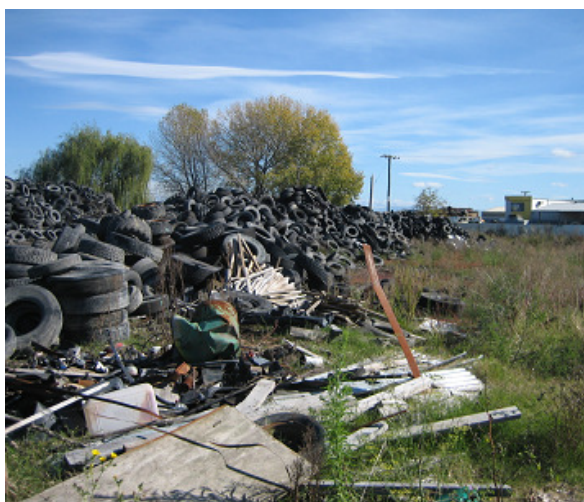
In common with many illegal waste dumps, the Mt Tyre dump also contained a quantity of non-tyre waste and general rubbish (wood, plastic and scrap metal) that had been dumped by the public or other parties (Photo 13). During the course of tyre clearance, more non-tyre waste was uncovered, including plastic and metal car parts, wire, scrap metal, masonry and empty gas cylinders (Photo 14).

**Photo 13: Rubbish dumped on site**

Any such non-tyre waste that was required to be moved as part of tyre clearance services (e.g. to gain access to the tyres or to create a clear firebreak with unrestricted fire vehicle access) was to be placed in a designated waste storage area. In practice, and to avoid double handling, a number of skips (metal, wood) were provided by LINZ for the contractor for this purpose. The filled skips were periodically taken to the local landfill (Omaranui Landfill) for recycling and/or disposal.

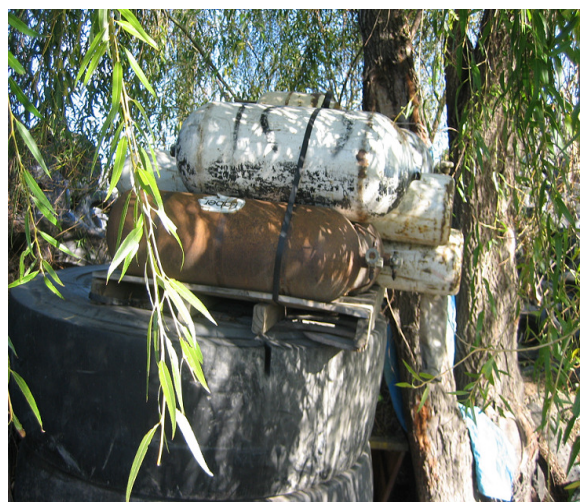
**Photo 14: Dumped empty gas cylinders**

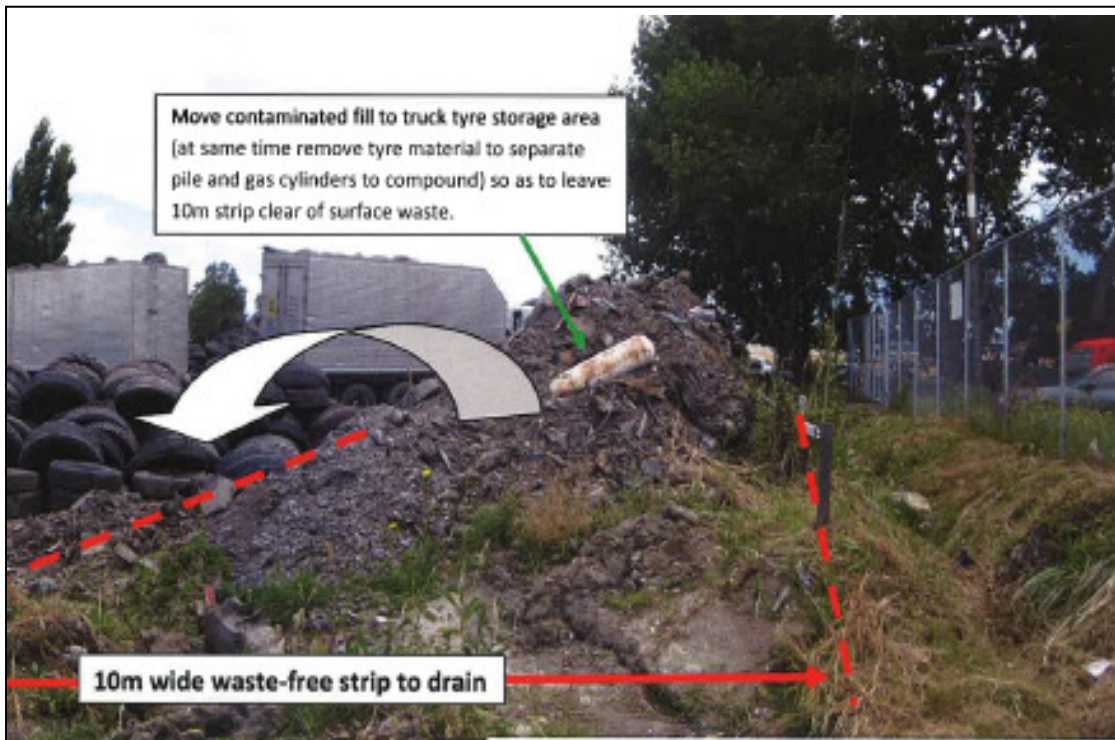
Two grassed stockpiles of spoil near the site entrance were required to be moved in order to meet the consent condition requiring the 10m zone adjacent to site drains to be kept clear of waste (Photo 15).

Tests showed the spoil heaps contained minor hydrocarbons and metal contamination (mainly copper, zinc and lead). Following confirmation that this material met the screening criteria for a Class A landfill, the spoil heaps were broken up by an excavator, sorted to

**Photo 15: Contaminated spoil heap within 10m waste-free strip adjacent to drain**

remove unacceptable waste (e.g. wire and masonry blocks) and the soil taken in sheeted trucks to Omaranui Landfill.
