## Pipes and pipelines: A challenging assessment at Ladybower Dam

*Vital pipeline survey required at 70-year-old Severn Trent dam*

**BY ADRIAN DAVIES-JORDAN**  
**PIPELINES ENGINEER, MWH**

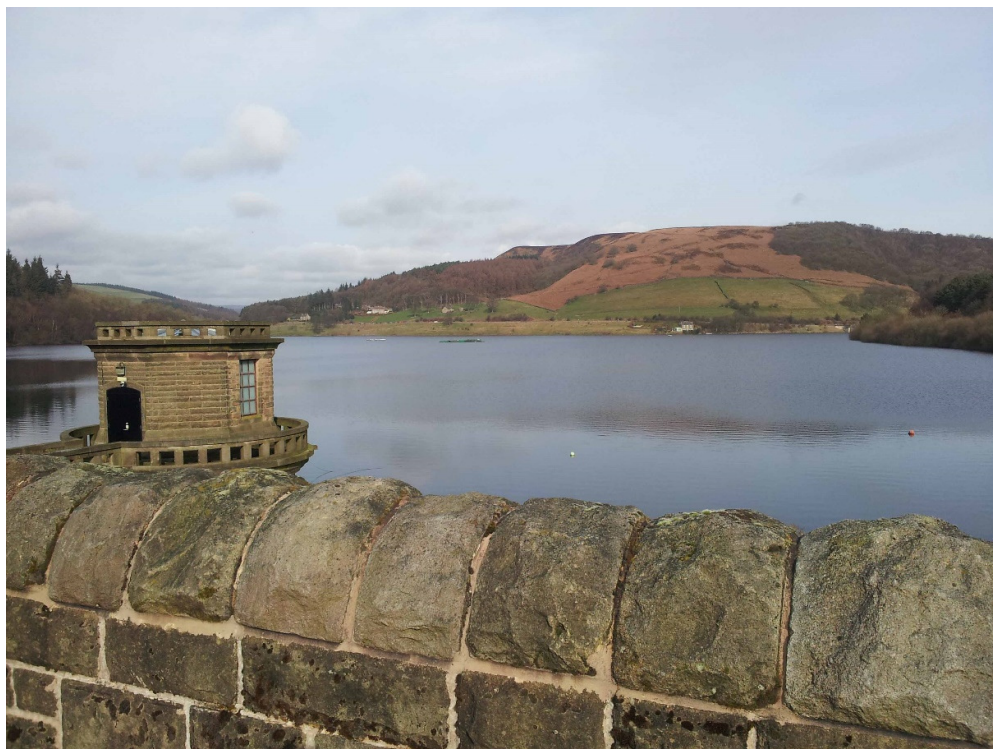
*Accessing the pipeline beneath the draw-off towers of the 70-year-old Ladybower Dam presented an unusual challenge*

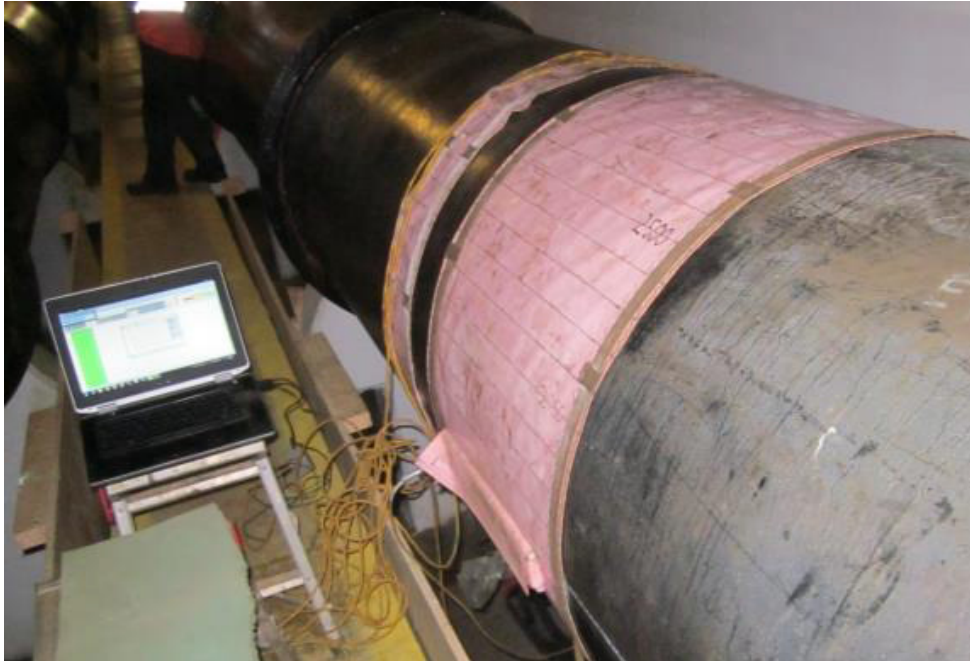
The BEM output gives an average wall thickness over a 50mm by 50mm square sensor. The total assessment area was the entire pipe circumference over an axial distance of 900mm. This meant that localized areas of wall thinning could be detected as well as maximum and minimum thicknesses. In all, 10 such assessments were carried out in each tunnel giving an inspection frequency of approximately 1 in 30, so we were able to gain a detailed picture of the current pipe condition. Having determined the wall thickness it was a straightforward step to calculating the current pressure resistance capability.

*A circular saddle was wrapped around the pipe so that its thickness could be monitored using the BEM sensor equipment. Lines on the saddle every 50mm indicated where measurements were taken.*
