DELIVERING INNOVATIVE INFRASTRUCTURE TO PROVIDE A CLEANER AND SAFER ENVIRONMENT FOR OUR COMMUNITIES

Abstract

Wastewater storage tank, pump station, overflow, Biogest®, vacuum flushing, Deep Soil Mixing, DSM

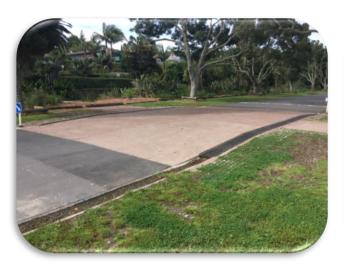
Figure 8: Completed speed table to protect pipes and allow bus access

For example, the hydraulic capacity requirements for the outfall pipes required twin DN600 outfall pipes. The pipes were limited by the Kohimarama Stream bed level and

thus the pipe soffits were close to ground level. Working closely with MWH, Watercare assisted in developing a unique speed table (hump) for a pipe protection solution that allowed the outfall pipes to be installed while maintaining a usable roadway and all parking areas in the park.

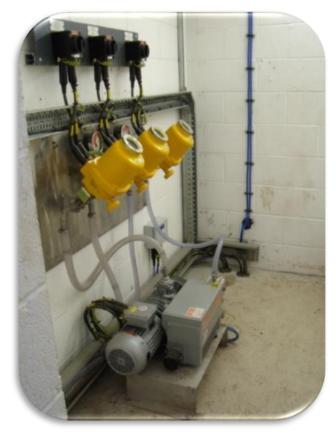
Figure 11: Vacuum Pump and Control Valves

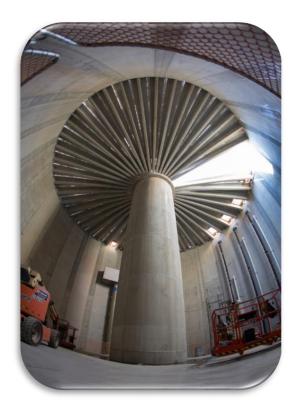
Figure 13: Tank Centre Column Showing PC Wall Panels and Roof Beams

The central column provides support to the tank roof and also serves as a reservoir for storing the liquid used in the flushing operation. The imposed axial loading and flexural bending demand on the central column are resisted by the precast concrete pipe and reinforced concrete infill. The GRP lining acts as a membrane to seal the area.

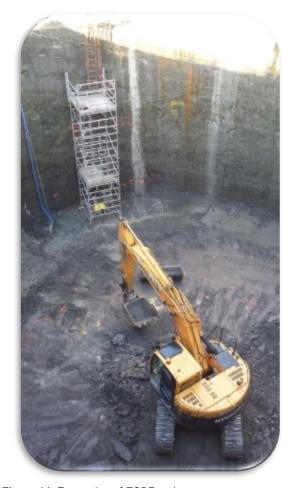
Figure 14: Excavation of ECBF rock

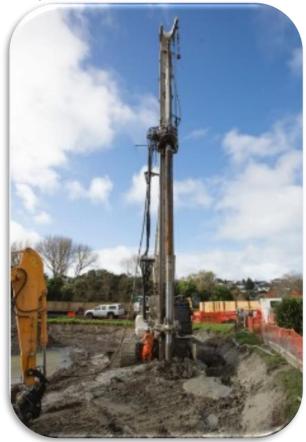
Figure 18: Site Works Commence with Installation of DSM Columns

FH successfully used DSM columns for excavation wall stability. DSM columns were made by mixing existing soil with high strength grout in situ to create low strength columns, which work very well in compression. The design for the tank included two rows of secant columns with a 1m key into the ECBF around the entire perimeter and an additional secant row around half the perimeter where the 400T crane worked from; this provided the additional necessary support for the lifts. DSM column depths ranged from 4.5-7m below ground level to achieve the key into the ECBF.

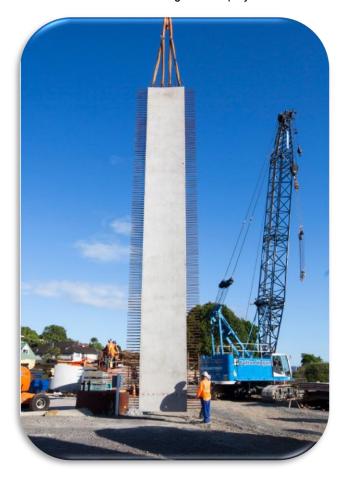
Figure 20: Precast wall panel and crane lift pad

Panel lifting involved a fully rigged 400t mobile crane at capacity sitting at the top of the excavation; with planning completed by site personnel, an independent lift planner, and lift planners from the crane company.

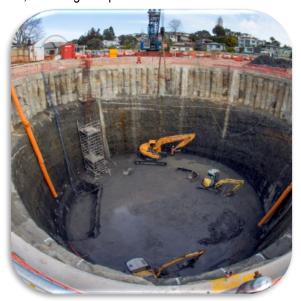
Figure 21: Showing Extent & Depth of Excavations Along With Forced Ventilation and Access Stairs

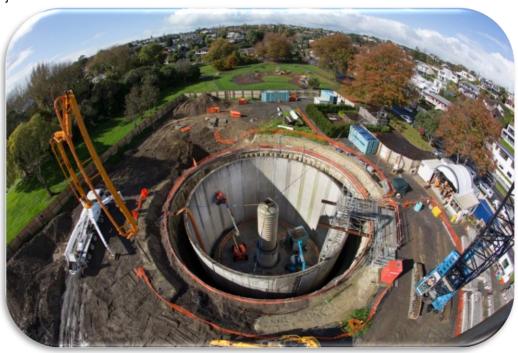
Figure 22: Overall site view during construction with GRP liner in tank center

The central vacuum column was constructed using a GRP liner, in situ reinforced concrete, and manhole risers. The GRP liner was constructed locally and tested offsite in a vacuum by charging it with water then opening a valve at the base with the top sealed, allowing the water level to drop, thus placing the liner under vacuum.
