## Opuha Dam Downstream Weir – Construction Update No. 3

As I said in my earlier post, two key considerations for the design and construction of the Opuha Dam Downstream Weir Enhancement are:

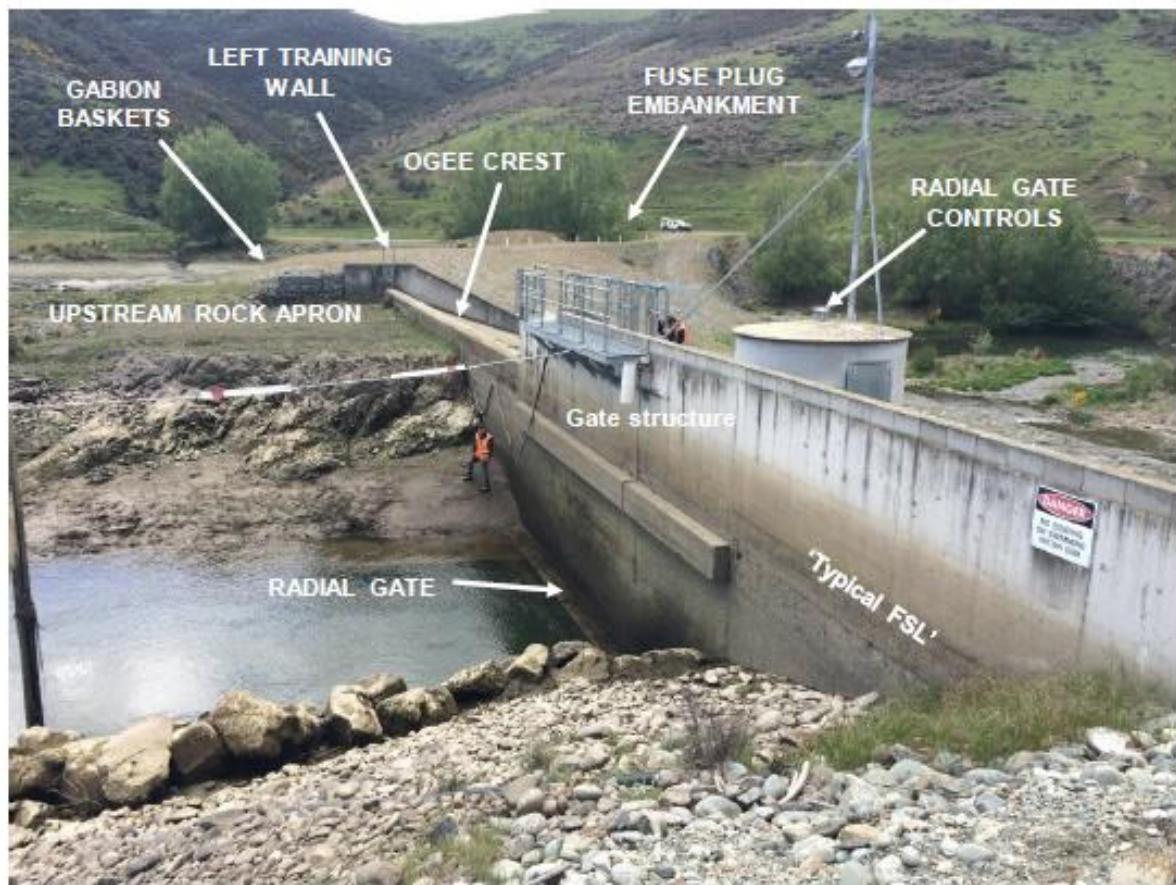
Development of a conventional cofferdam is straightforward for most of the concrete spillway, as a rock apron is present immediately upstream of the weir (refer image below). This reduced the height of the cofferdam at this location and makes it readily constructible.

Over the right side of the concrete spillway however, the rock level is much lower (refer above, near the location the person is standing). In addition, this section of the concrete spillway is immediately adjacent to the existing radial gate, which acts as the diversion works for construction (refer above, submerged).

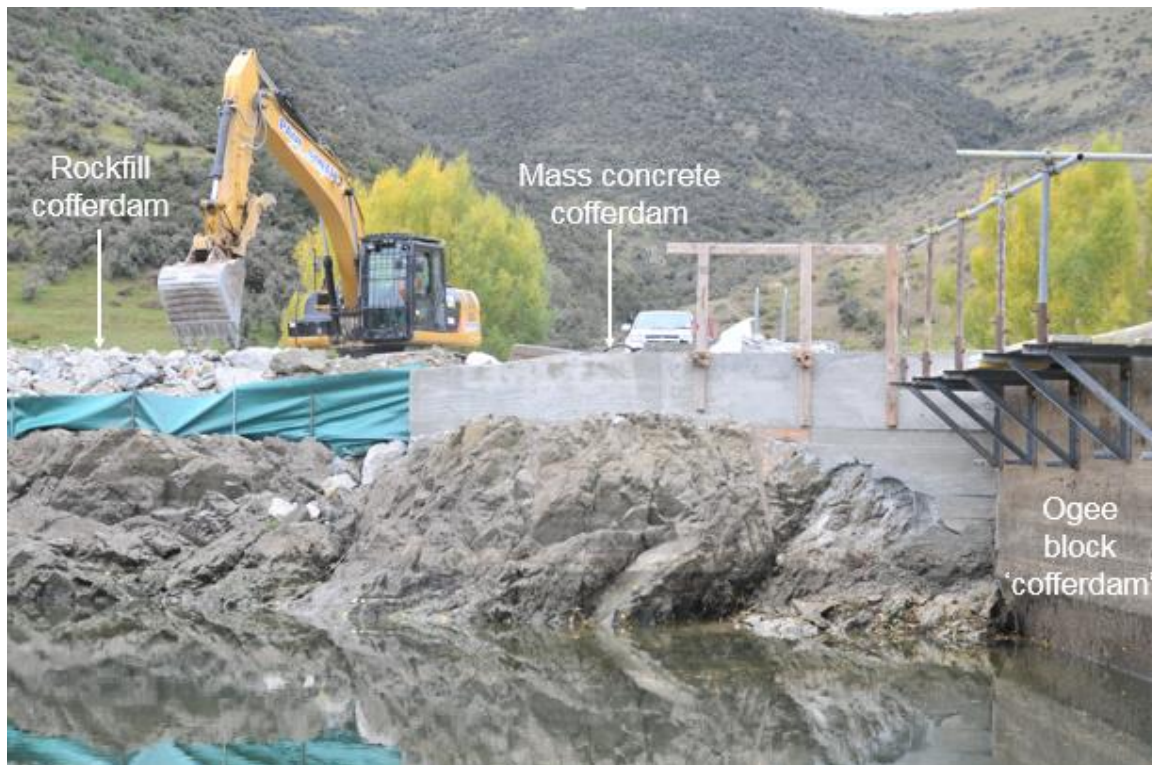
It was therefore determined by MWH that a section of the concrete spillway ogee crest should be used as part of the cofferdam. The upgrade works could then be completed behind the cofferdam, with the remaining section of spillway crest removed at the end of construction. Below is a view of the completed cofferdam, including the section of ogee crest which forms part of the cofferdam. The cofferdam arrangement is also depicted below in the construction staging. This arrangement greatly reduced temporary works (cost and schedule) and helped reduce construction risks.

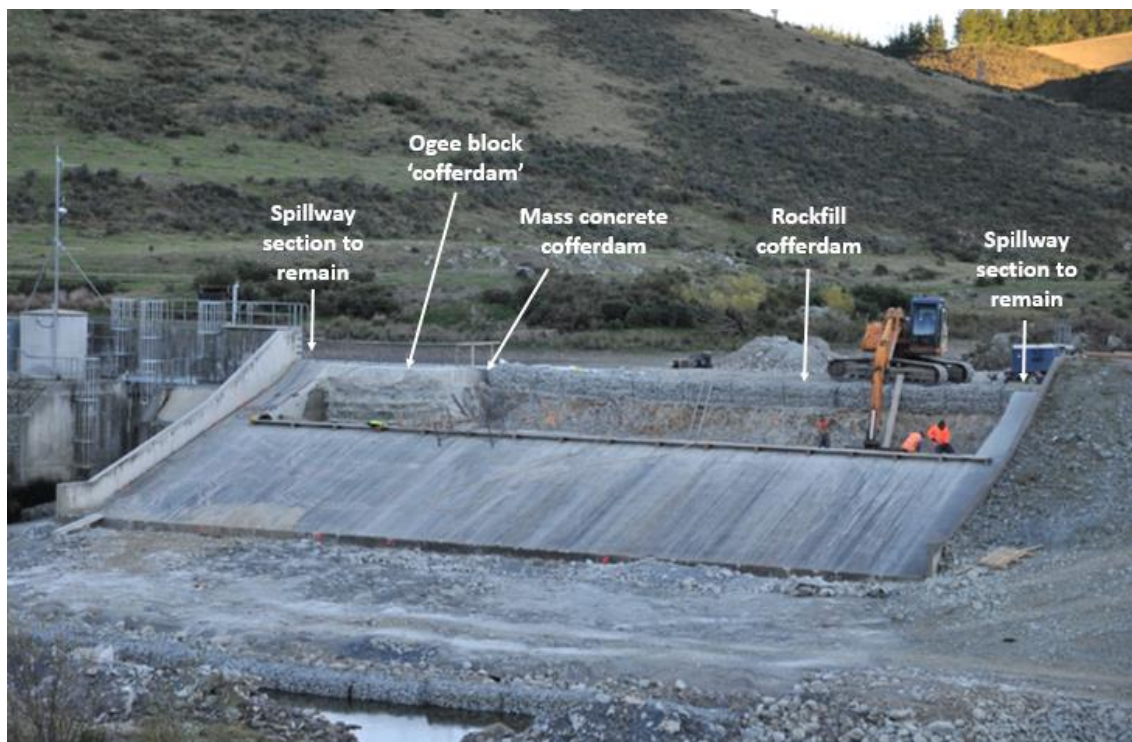
Another key MWH idea to improve constructability was to avoid spillway lowering over the full width of the spillway. A short section of ogee crest is being left at each side of the spillway, separated from the lowered spillway section by new internal training walls. The excavation has therefore been made narrower and deeper, to get the same flood capacity. This idea removed the requirement to tie the new works into the existing training walls, together with the associated risks (such as the potential to destabilise the training walls and the associated embankment behind (true left)). The section of spillway ogee crest being left in place can be seen in the image below, viewed from downstream.
