## Opuha Dam Downstream Weir Enhancement – Construction Update No. 5

- Owner: Opuha Water Limited
- Contractor: Breens Construction Company
- Designer: MWH Global
- ETC: Tim Anderson

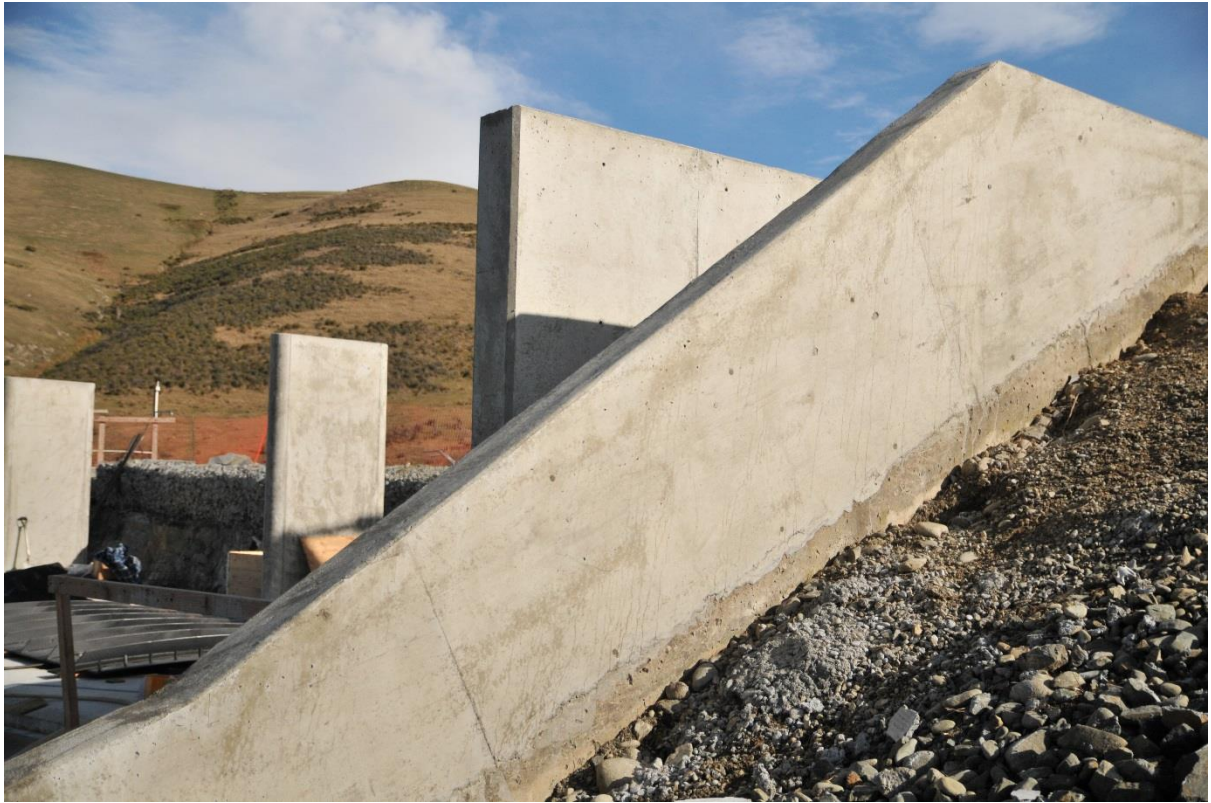
Below are two images of some of the completed concrete works, which still need minor finishing works. The first image shows one of the existing training walls which has been raised, with the new internal training wall and new bridge piers behind. The second image shows one of the completed bridge piers, which will support a steel walkway over the upgraded concrete spillway. Previously, access across the spillway was not possible while it was spilling, so the new walkway will provide permanent access to the control building and right abutment area.

The structural concrete works are relatively straightforward. The key challenge was understanding the as-built nature and condition of the existing concrete works that would have to integrate with the new concrete works. The concrete spillway was constructed in the late 1990's so as-built details were available, and it was concluded that the spillway is generally in good condition.

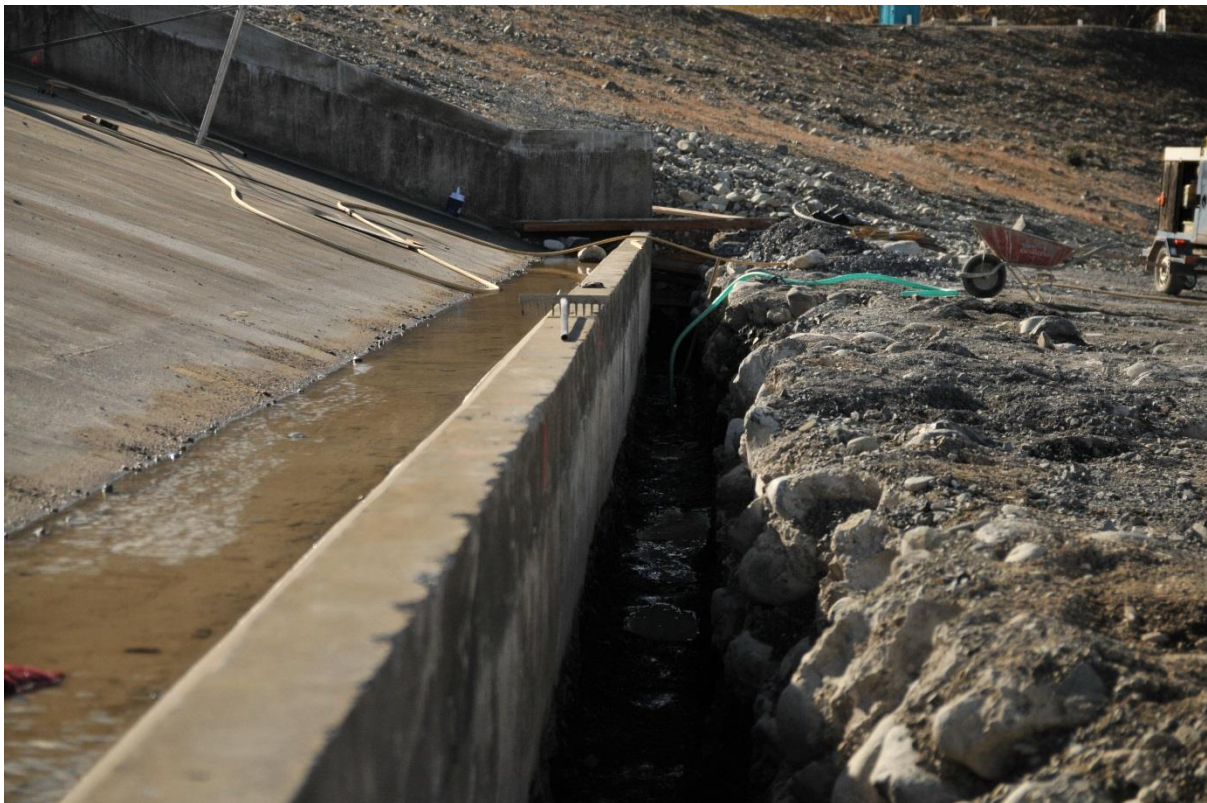
The key components of the erosion protection works are a new cutoff designed to prevent any backward erosion undermining the concrete spillway, and a new steel fibre reinforced concrete slab in the 'stilling basin' area. As can be seen in the image below, the cutoff trench has been excavated down into rock and will soon be ready for steel and concrete. The toe of the existing spillway can be seen on the left, with the existing erosion protection slab on the right (on which the new erosion protection slab will be constructed once it is cleared and prepared).

In addition to the main structural concrete works, construction has also been progressing on the erosion protection works immediately downstream of the concrete spillway. The erosion protection works are designed to prevent potential erosion downstream of the spillway due to the increased flood flows which can be passed by the upgraded spillway (and slight increase in flow velocities expected due to the upgrade).
