## Opuha Dam Downstream Weir Enhancement – Construction Update No. 1

MWH is responsible for the detailed design and construction supervision of the upgrade of the Opuha Dam Downstream Weir (South Canterbury, NZ), owned and operated by Opuha Water Limited.

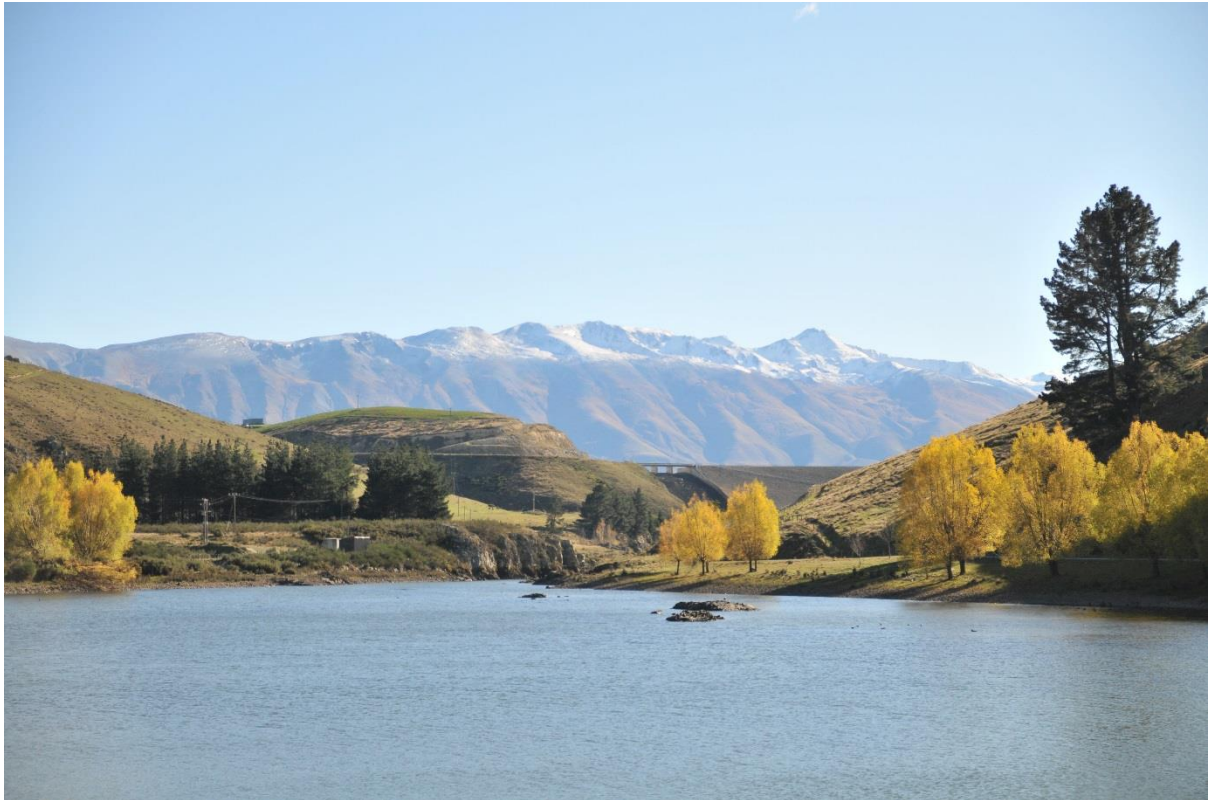
The weir serves to reregulate releases from the Opuha Dam powerstation, which is typically used as a peaking station, back into the Opuha River for irrigation and environmental purposes.

The weir is a composite structure and includes a permanent embankment, a gate structure with radial gate, a concrete spillway and a fusible embankment. The weir is classified as a 'Large Dam' in accordance with the NZ Building Act and a 'low' potential impact classification (PIC) dam in accordance with the New Zealand Society on Large Dams (NZSOLD) dam safety guidelines.

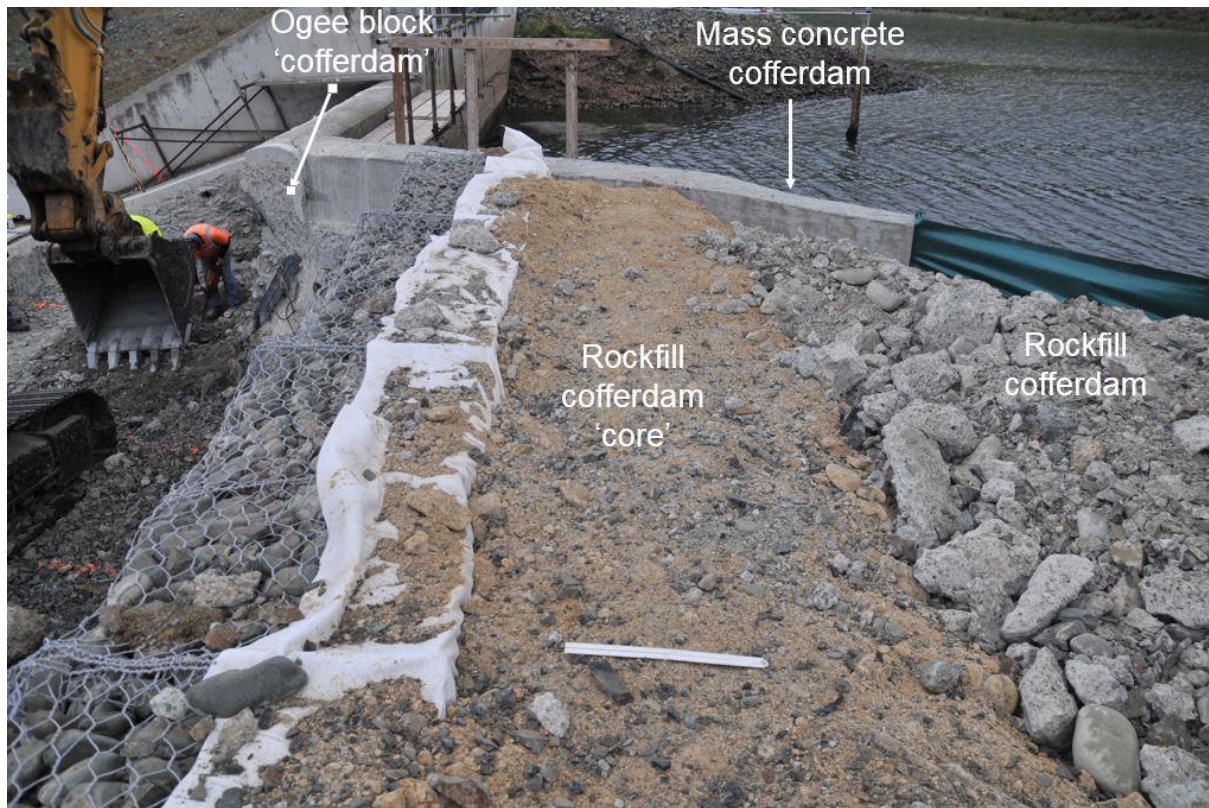
Construction commenced in April 2016. Temporary works, including the cofferdam, were completed in early-May 2016. A section of the concrete spillway ogee crest has been left in place, and is being used as part of the cofferdam. This section of spillway crest will be demolished towards the end of the project under a reduced pond level, with remaining concreting works upstream of the installed gate completed at this time. A temporary mass concrete wall ties the ogee block 'cofferdam' to the conventional rockfill cofferdam. Here is what the cofferdam arrangement looks like:

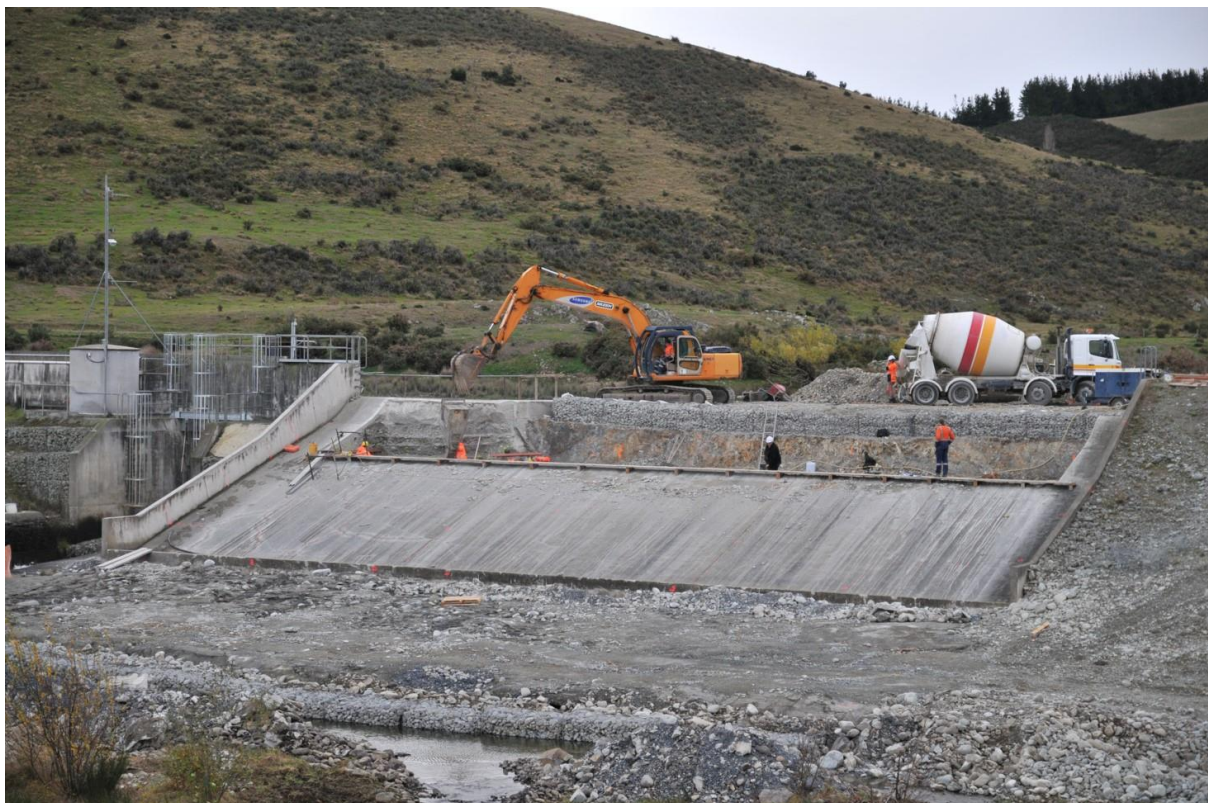
And here is what the weir looks like currently, with the spillway cut down completed and foundation preparation works in progress:
