## Opuha Dam Downstream Weir Enhancement – Construction Update No. 2

As I mentioned in the my first post, the primary objective of the Opuha Dam Downstream Weir (ODDW) Enhancement is to increase the flood passage capacity of the weir from 120 m<sup>3</sup>/s to 250 m<sup>3</sup>/s, prior to commencement of overtopping of the fusible embankment. This increase in flood passage requires modifications to the existing concrete spillway. Refer to my earlier post for a summary of the enhancement works.

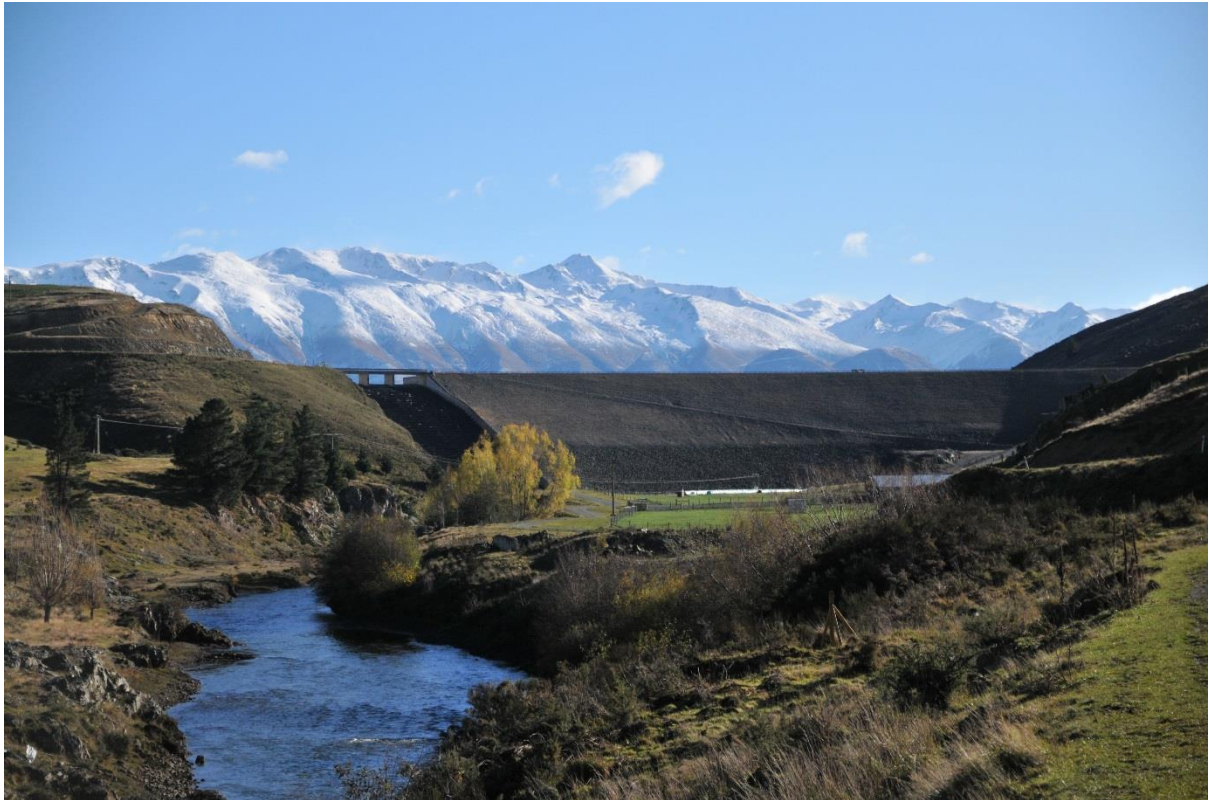
Significant floods at the weir location occur primarily from the Opuha River catchment. Immediately upstream of the weir is Opuha Dam (refer image below). Opuha Dam serves to attenuate floods through the weir. Construction works have been planned to occur when Lake Opuha levels are historically at their lowest. This is immediately following the irrigation season. Lake levels are currently just below average for this time of year and there is a significant volume of flood attenuation currently available. This currently equates to around 30 MCM (million cubic meters) flood storage.

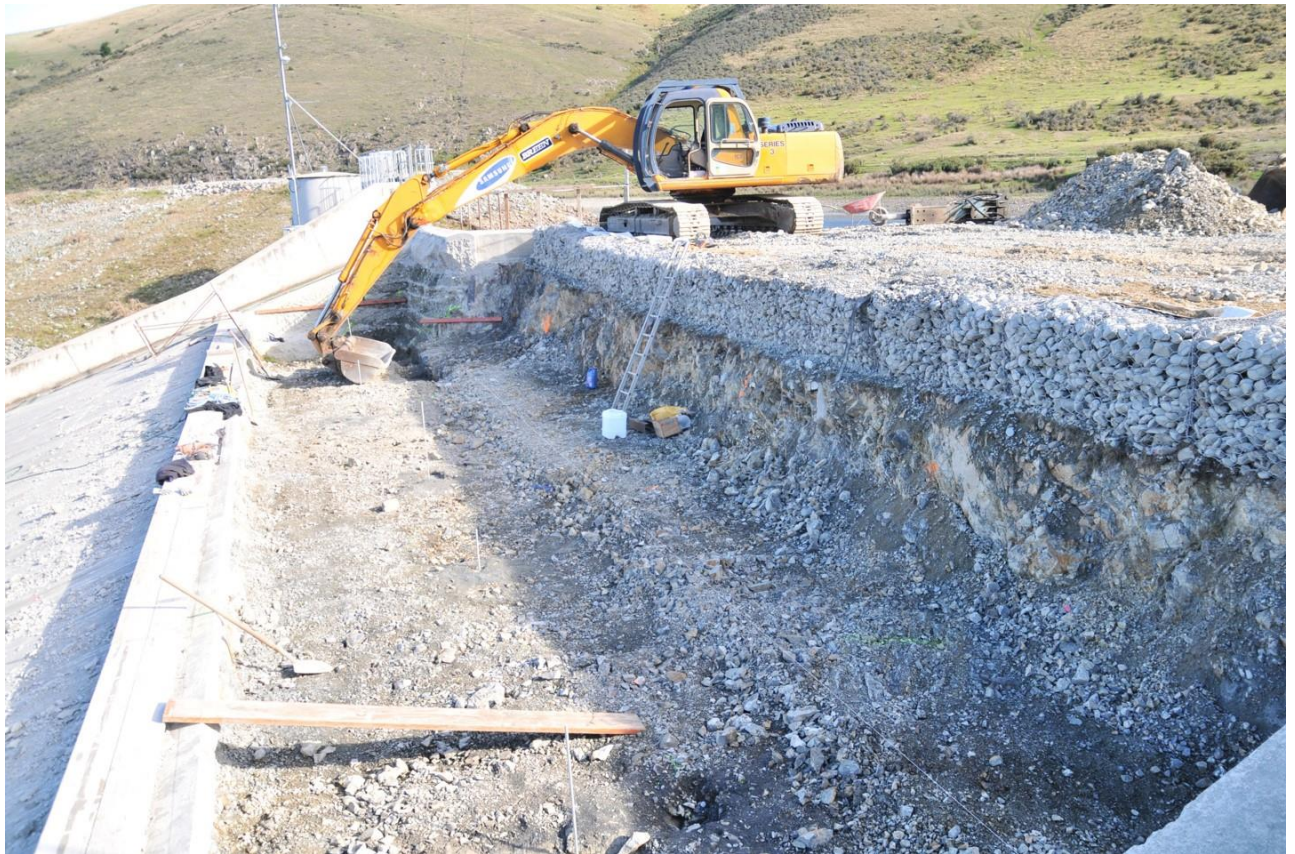
As I said in my earlier post, the enabling and temporary works have been completed. The mass excavation for the cut down of the concrete spillway crest has occurred over the last couple of weeks. The image below shows the spillway cut down (approximately 2 m), with the digger sitting on top of the cofferdam.

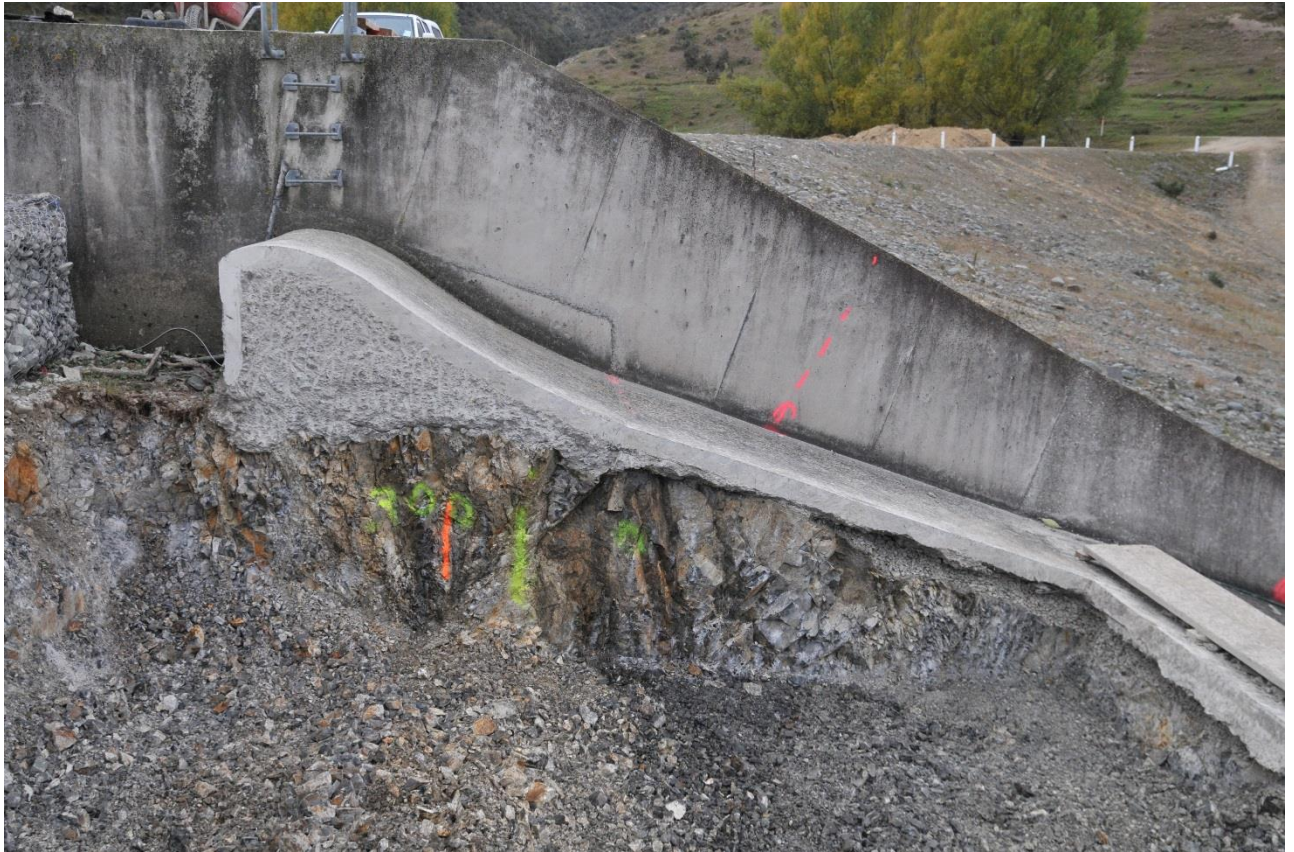
Below is a nice image showing a section through the left side of the concrete spillway. It shows the ogee crest formed on mass concrete, with the reinforced spillway slab sitting on a thin drainage gravel on top of 'greywacke' rock. The left training wall is behind, with the fusible embankment in the background.

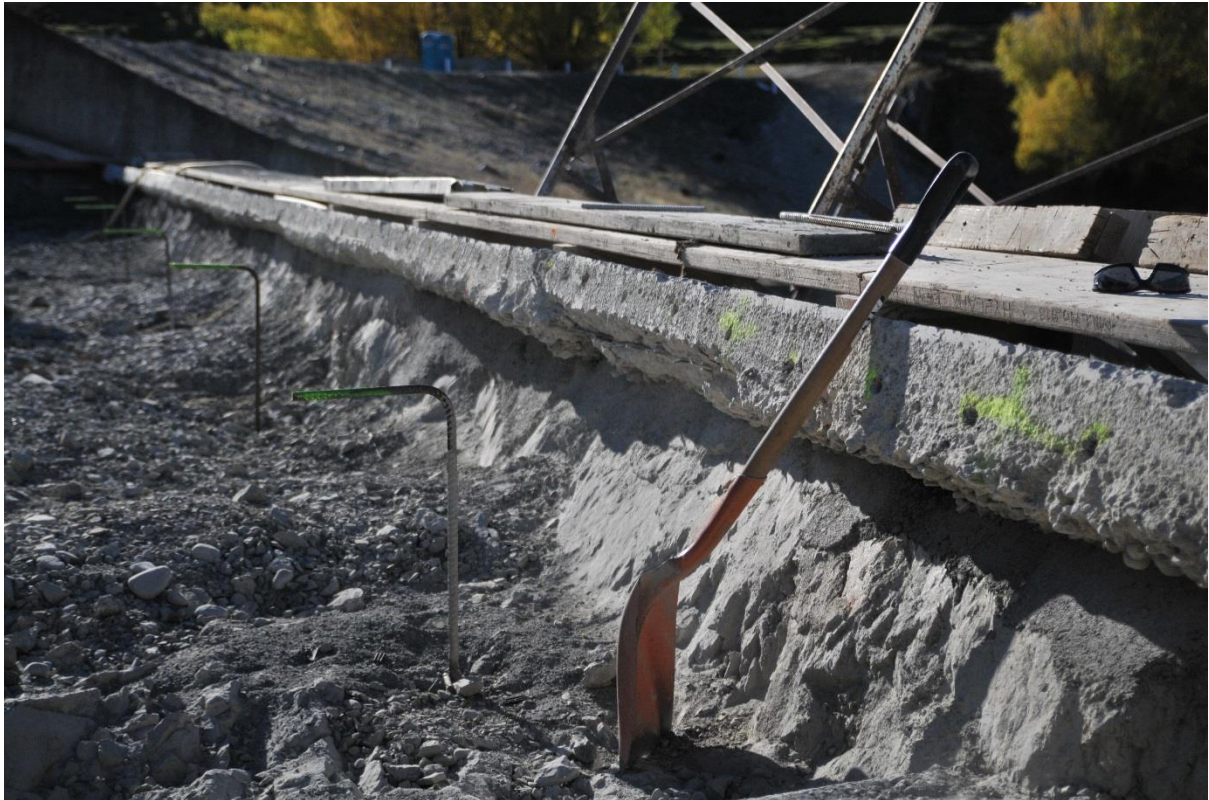
As detailed above, allowing the concrete spillway to still be used during construction if required, was based upon exposing materials judged erosion resistant. It was planned to seal the drainage gravel beneath the slab with concrete and this has been completed. This can be seen in the image below, at the far right of the image below the existing spillway reinforced slab.

- This is with the exception of the existing drainage layer beneath the reinforced spillway slab, which will be exposed on spillway cut down. It was planned to face off this drainage gravel material with site concrete immediately on exposure (as would any inferred erodible rock if encountered).

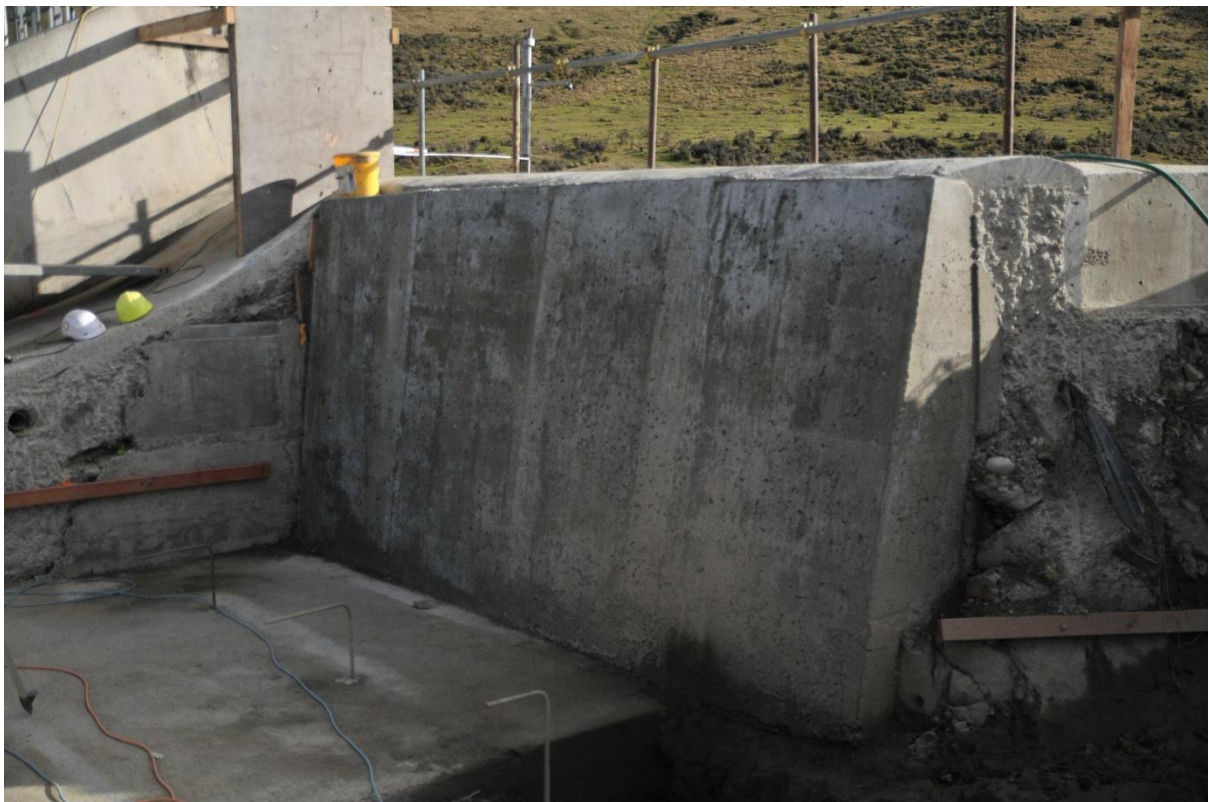
The 'stabilized fill' has also been temporarily sealed off with concrete, just in case spilling was to occur. As can be seen below.
