# BUILDING ON NEW ZEALAND'S MOST CONTAMINATED SITE – THE MAPUA WHARF WASTEWATER PUMP STATION

Avik Halder, MWH NZ Ltd.

This paper describes the award winning Mapua Wharf Wastewater Pump Station project.

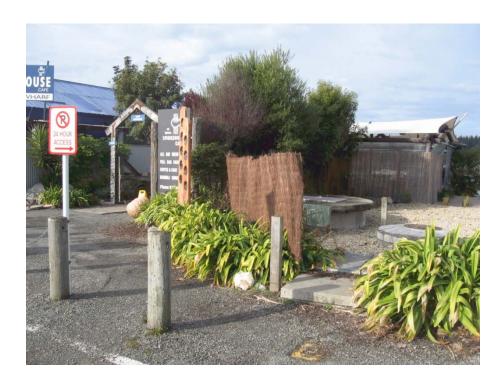
The original pump station next to a popular restaurant in the Mapua wharf area

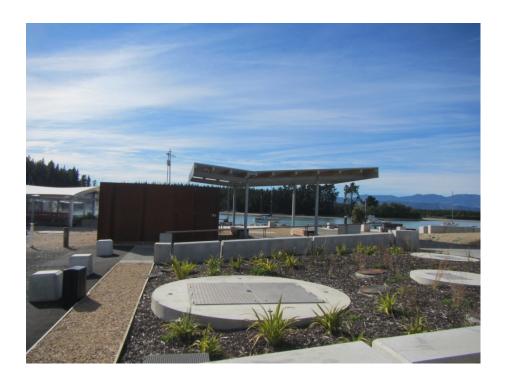
The finished product: a pump station that blends with its surroundings including the restaurant and a public recreation area

As the pump station was to be integrated into a waterfront development in a highly public area the finished pump station site had to be cleverly landscaped. This required the individual components to be profiled to fit the landscaped finished levels and provide public access over the whole site. The design had all the new structures except the standby generator and surge vessel underground with other elements designed out of the direct site to not bring attention to the facility.

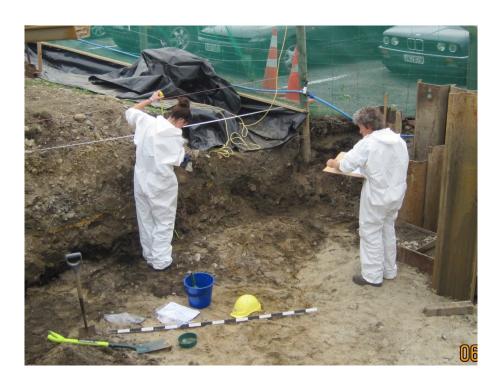
Taking soil samples

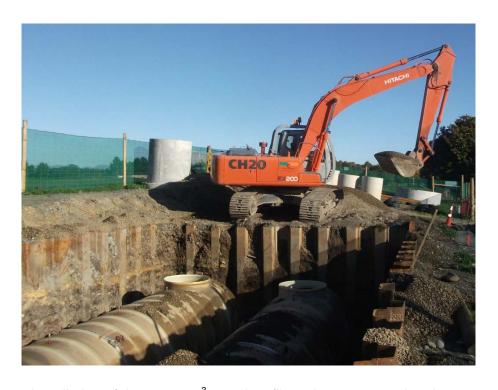
Installation of the two 30m³ propriety fibre-glass storage chambers

Due to the space constraint the obvious solution would be to design elements at a greater depth to allow a smaller footprint however this would have increased the excavation into the deeper remediated soil layers and also increased the amount of dewatering. To overcome this, elements such as GRP storage tanks were used that could be constructed under water at relatively shallow depths.

MWH's design minimised the volume of earthworks where possible and the amount of dewatering by cutting off groundwater via sheet-piling and using GRP tanks that could be constructed under water if necessary.
