# City of West Palm Beach Makes Priority Improvements to Aging Water Treatment Plant

Gerardus Schers, Becky Hachenburg, Heath Wintz, Brian LaMay,  
Don Lythberg, Sam Heady, and Poonam Kalkat

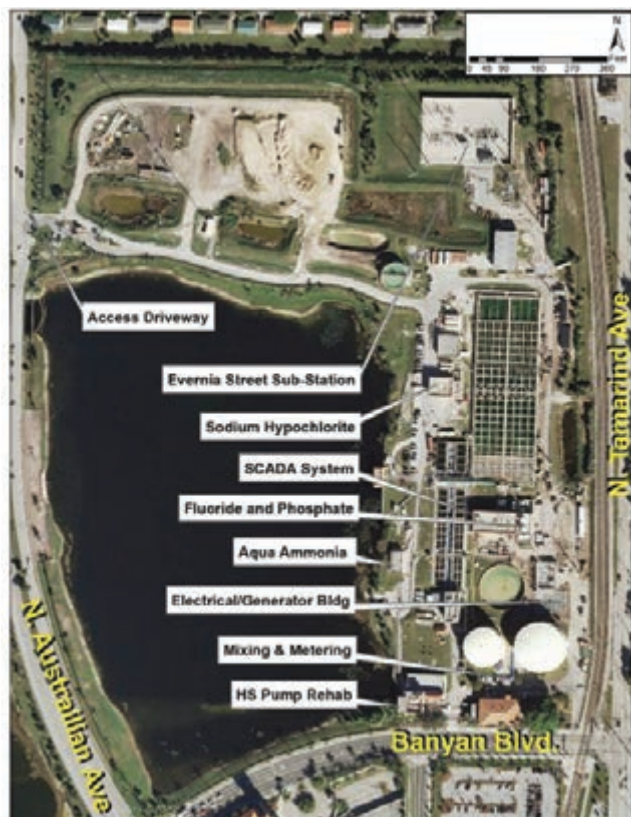
Figure 2. West Palm Beach WTP Site Plan with Priority Projects Highlighted.

These projects are spread across the WTP site, as illustrated in the graphic, requiring close

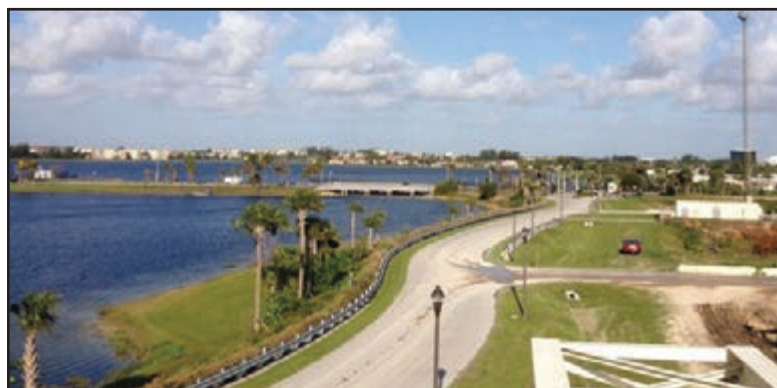
Figure 3. Safe Access Driveway from Australian Avenue.

To reduce the risk presented by this entrance, a new plant-access driveway was constructed along the north side of the property from Australian Avenue—a larger thoroughfare. This new access driveway included a dedicated turn lane, security guard checkpoint, video surveillance, and card-swipe-access control for the City staff. Chemical deliveries, sludge transport,

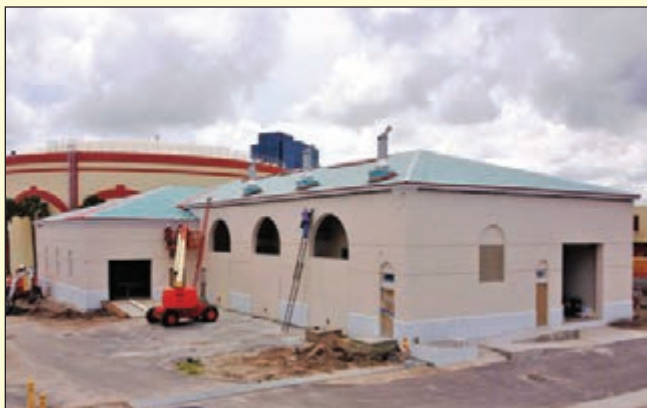
Figure 4A. New Electrical/Generator Building Increases Reliability of WTP Service.

To address these issues, MWH designed a new electrical/generator building and a dedicated “express” electrical feed from the Evernia Street substation located on the WTP site. The new generator building includes three 2,500 kW generators, an air intake rain knockdown plenum, sound damping exhaust plenum, and a new Florida Power and Light transformer vault, as well as 4160V primary and generator switchgear. The express electrical feed, augmented with two additional utility feeds from the Evernia and West Palm Beach substations, provides power to the double-ended switchboards and subsequently to all equipment, with an option to seamlessly transfer between utility and on-site generated power. This transfer feature is of critical importance during the wet season, allowing seamless transitioning between preferred power sources. Proactive management between sources helps to navigate through brownouts and blackouts and avoids interruptions to the treat-

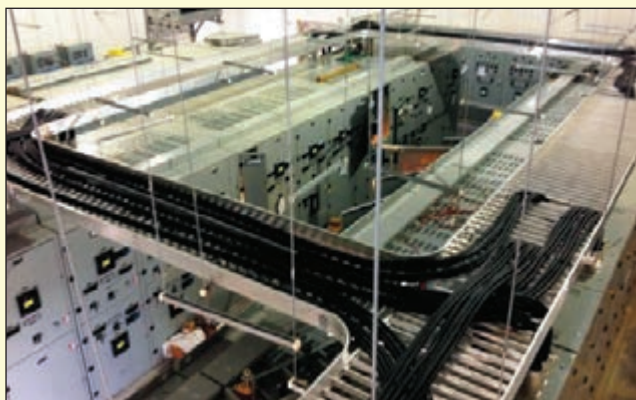
Figure 4B. View on Double-Ended Main and Generator Switchgear.

tomated and replaced with state-of-the-art equipment. A new electrical/generator building with an express power feed is under construction with double-ended switchgear and standby generators providing reliably power to all equipment, with an option to seamlessly transfer between utility and generator power.

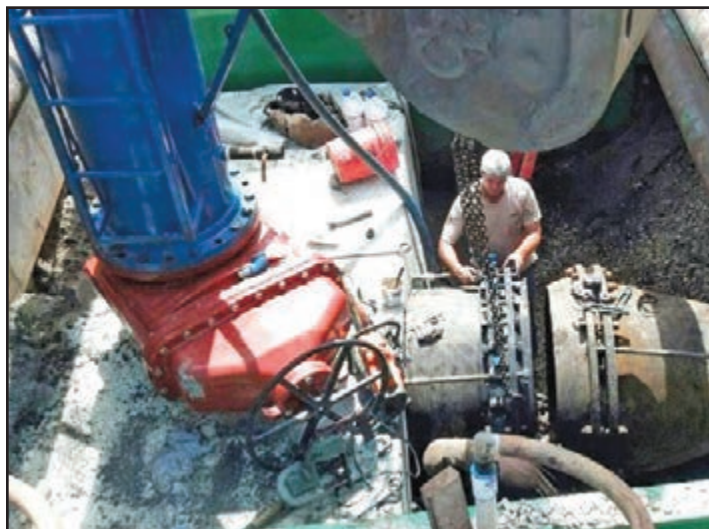
Figure 5. 42-in. Line Stop to Bypass In-Service Water Main Supplying.

Construction of the generator building at the heart of an aged facility has not been without challenges. During construction, unreliable record drawings of underground utilities and inoperable isolation valves complicated the relocation of a 42-in. finished water line. To facilitate the relocation, 42-in. and 24-in. line stops were installed to bypass this section of the pipeline, which was nearly 15 ft deep and located only 25 ft away from a railway. The project team members, including MWH, ensured that adequate shoring and thrust restraint was provided for this hot tap. The work was done successfully and this section of pipe was bypassed, while protecting the arterial line supplying potable water to the downtown area.

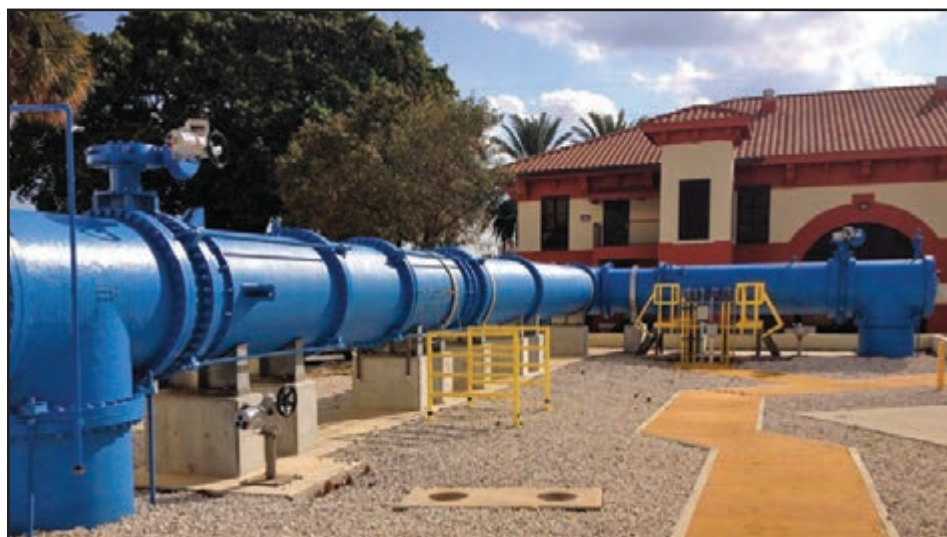
Figure 6. Mixing and Metering Header.

The existing chemical injection points relied on turbulence from fittings and pipe bends, which provided incomplete mixing and reaction. Furthermore, finished water chemicals were dosed based on an aggregate flow from 26 individual filter effluent flow meters. With an inaccuracy of  $\pm 0.5$  percent each, the total inaccuracy of the finished water flow signal could be as high as  $\pm 13$  percent. To alleviate these issues, the City constructed an above-grade 48-in. in-line static mixer and a centralized venturi flow meter between the transfer pump station and the ground storage tanks. Since the system only has enough storage to be off line for 8 hours, the design included a 20 mgd temporary bypass system from the transfer pump clearwell to the ground storage tanks to enable the WTP to remain in service during the construction tie-ins.

The centralized flow meter provides a signal by which all finished water chemicals are flow-paced with greater accuracy and reliability. A major improvement to the process and to finished water quality has been the addition of the mixing and metering header, and the automation of the finished water chemical dosing and controls.

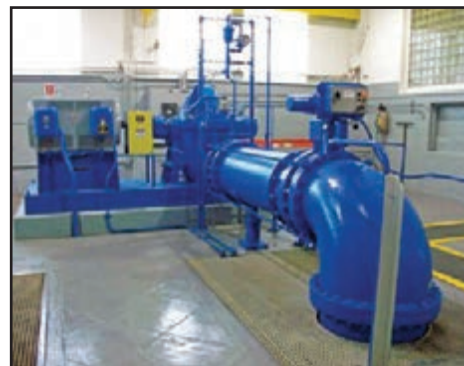
Figure 9. High-Service Pump No. 7.

- ◆ High-Service Pump 3 – The current impeller only draws 235 horsepower (hp) from the existing 300 hp motor. Additionally, the pump curve is “flat” and the operating head is much lower than the other pumps. This results in reduced output when the other pumps are in operation, making the pump least useful when it is most likely needed. Installing a larger-diameter impeller to take advantage of the existing 300 hp motor increases the operating head, thereby increasing the capacity of the pump.
- ◆ High-Service Pumps 6 and 7 – The pumps operate near the shutoff head and draw less than their rated capacity when the distribution system pressure is high. Installing larger-diameter impellers takes advantage of the existing motors to increase capacity with minimal capital cost.
